# Determination of the optimum parameters for the process of manufacturing thin concrete slabs

■ Holger Stichel und Stefanie Schaarschmidt, Kobra Formen GmbH, Germany

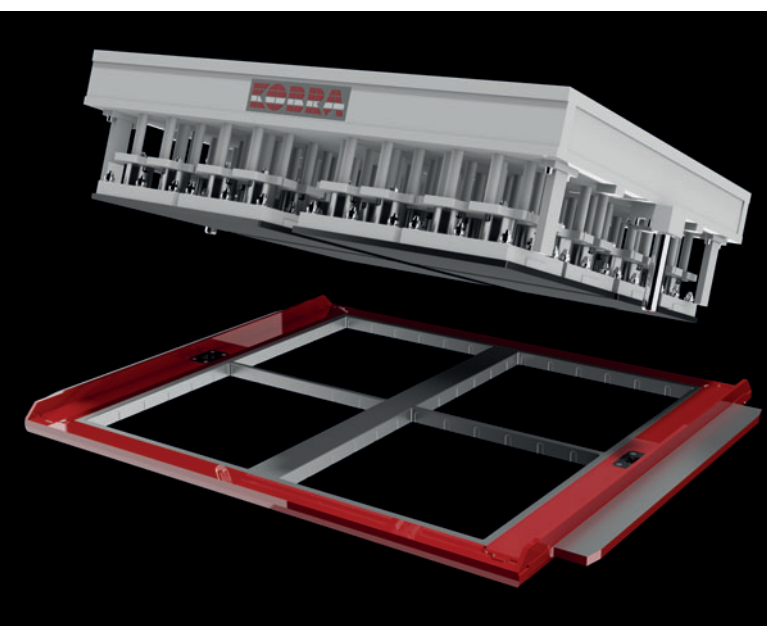
Figure 1: Slab mould 60 x 60 x 4 cm

The concrete block mould (60 x 60 x 4 cm) shown in fig. 1 was developed and manufactured by Kobra Formen GmbH. Excluton and Kobra cooperate closely in the creation of new block systems, which already begins with the implementation of product ideas – frequently drawings or photographs – in products that can be produced with concrete block moulds.

In this case the mould exhibited an above-average degree of wear in comparison with the number of cycles, therefore a cause analysis was carried out by two Kobra service engineers under real conditions, i.e. during the manufacturing process. In the manufacture of very low concrete block products it is essential to note that the stability of the mould is limited on account of its similarly low height and that the machine must be set up for a very precisely dosed application of force to the tool. In addition, the tamper shoes were manufactured with mini-chamfers in the specific example, which are subject to particularly high loads during production on account of the minimal super-elevation of the mould. A recipe with strongly abrasive raw materials also increases wear.

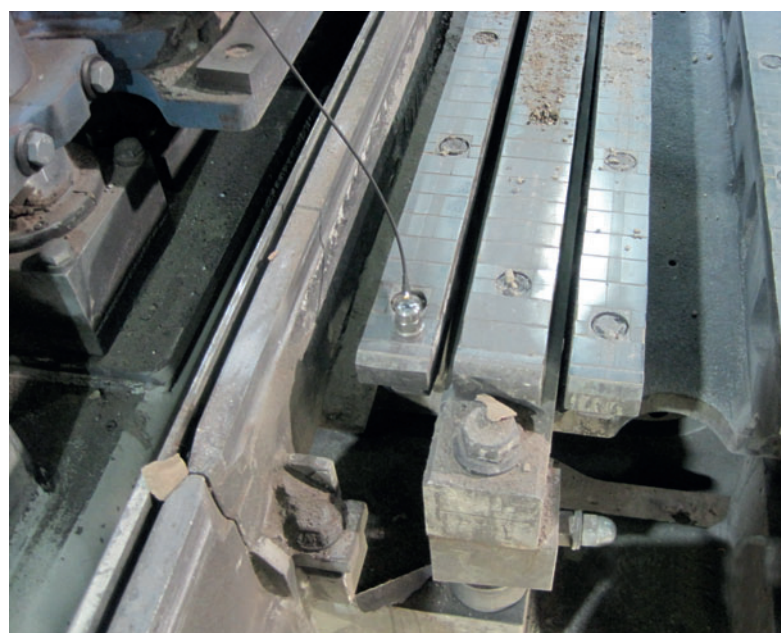
Figure 2: Back stop measurement

To this end a vibration measurement was first carried out on the machine to rule out damage to the machine table. Attention was also paid to the adjustment of the back stops on the vibrating table, as irregularities can lead to fluctuating compaction results and, consequently, varying stone heights.

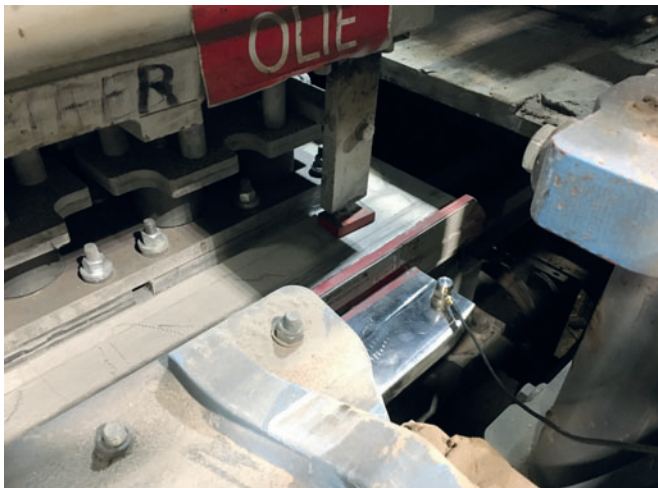
Figure 3: Vibration measurement on the concrete block mould

In the next step vibration measurements were carried out directly on the concrete block mould during the running production process with the machine settings chosen by Excluton.

Following the evaluation of all the data, the machine settings were modified in accordance with Kobra's recommendations and the production sequence was examined again with vibration measurements and high-speed camera photos.

The results of the two measurement series were compared by Kobra and the machine settings adjusted in further test series until the desired result and thus manufacturing conditions tuned precisely to the product were achieved.

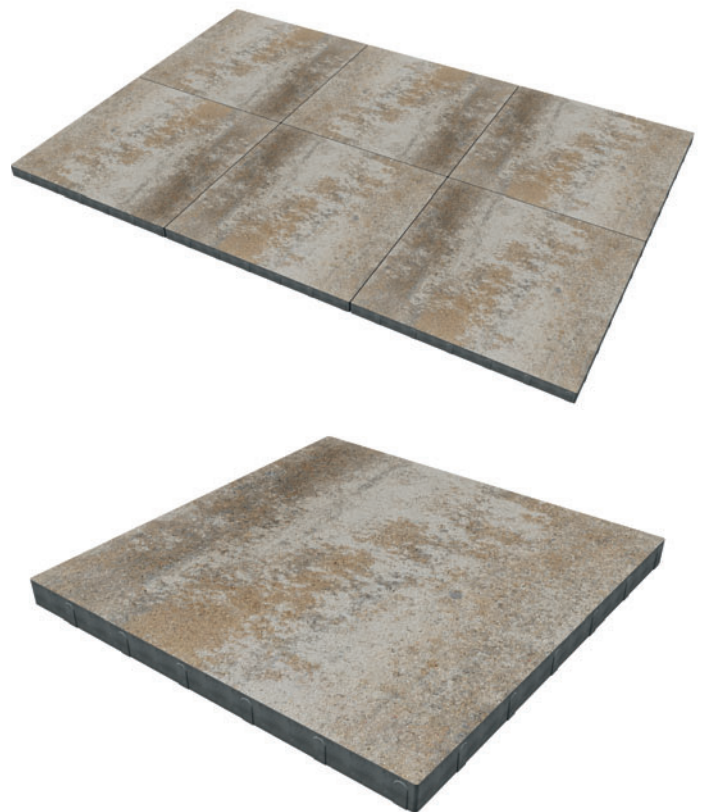
Figures 4 a, b: Excluton concrete slabs

In cooperation with the two responsible employees from Excluton, it was possible in the example shown here to determine and calibrate the ideal parameters for the process of manufacturing concrete slabs with a low stone height. These parameters are not only essential for the product quality, but also verifiably reduce the rate of wear in the mould and machine. ■
