# Condensation causes Corrosion

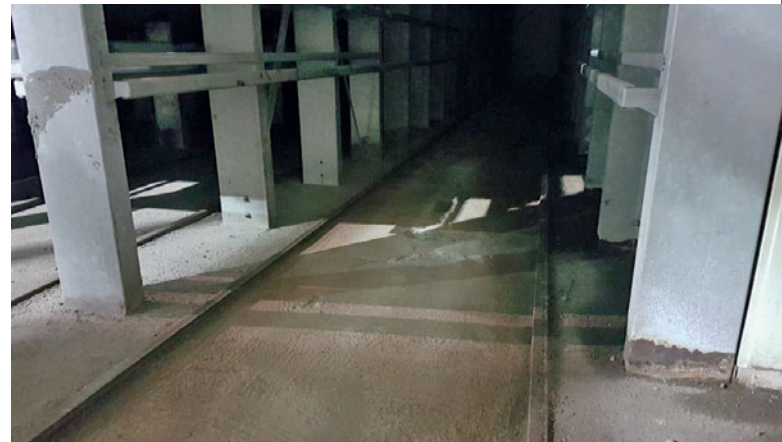
*Typical effect of condensation: columns closer to the chamber's center are dry and free of corrosion while those located at the perimeter (right) have corroded at the bottom*

the prevailing temperature over time. However, if you look at which columns are affected, one will usually find the perimeter columns corroded.

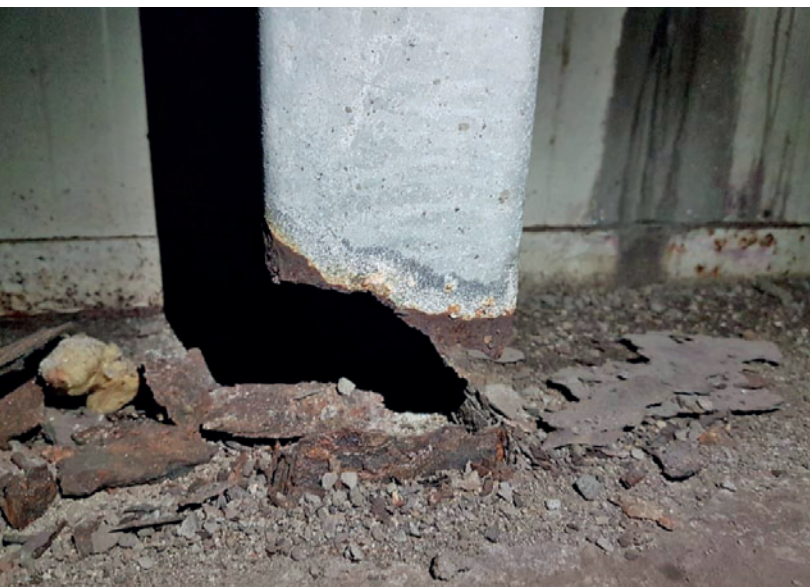
*Column corroded due to condensation. This completely corroded lower column portion is only held in place by the rest of the rack system and requires immediate replacement*

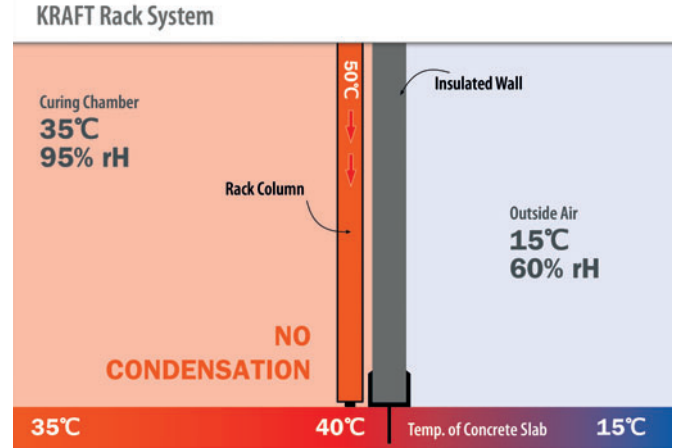
No condensation with the new Kraft Rack: the columns, used as air ducts, become part of the curing system and remain warm and dry. The concrete floor/slab can no longer act as a thermal bridge.

Kraft Curing offers a much more obvious solution. Kraft's new integrated curing rack is designed in such a way that the air distribution system for the curing chamber is incorporated in the load-bearing structure - the columns. The rack steel is used as ducts to consistently distribute air, humidity and heat evenly throughout the entire curing chamber, independent of the chamber's size.

The perimeter columns are heated up and, in turn, heat up the concrete floor, moving the thermal bridge to the outside of the chamber and preventing the formation of condensation. The warm concrete floor radiates heat into the chamber, contributing to the curing process. This elegant solution does not only result in an extremely uniform curing climate, but also guarantees that the entire load-bearing structure remains dry on a permanent basis despite providing optimum moisture for the concrete curing process. All columns, including those located at the chamber's walls, will permanently remain dry and protected from corrosion. Consequently, the complete rack system will remain intact and will not have to be replaced even after years of operation.
