Thermal images help assessing insulation issues in curing chambers

Michael Kraft, Kraft Curing Systems GmbH, Germany

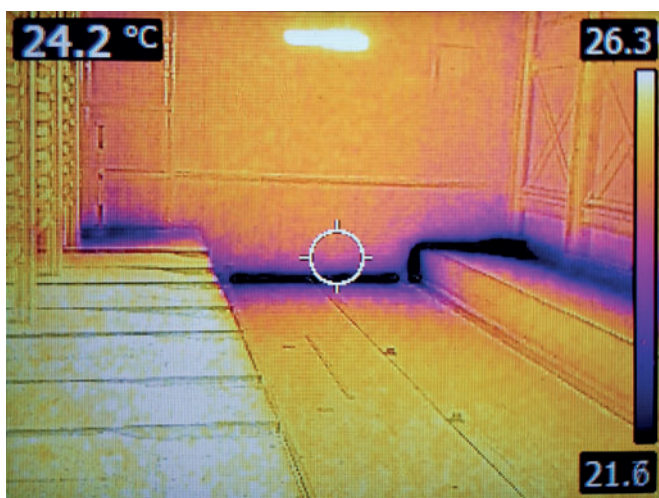
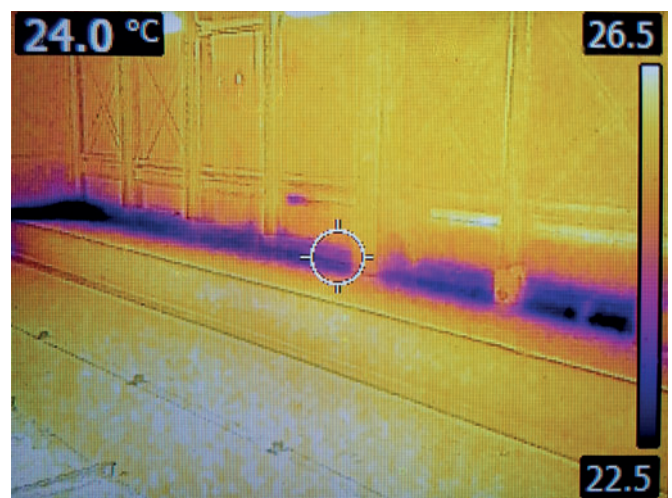
These thermal images show a well heated and circulated curing chamber - only lacking insulation of the concrete slab around the outside of the perimeter of the curing chamber. The floor in the transfer car area is bright yellow to orange, turning to darker purple as it proceeds to the exposed concrete slab. This is especially noteworthy in the recessed transfer car area. Adding insulation to this exposed slab would prevent the chance of standing water in this area.

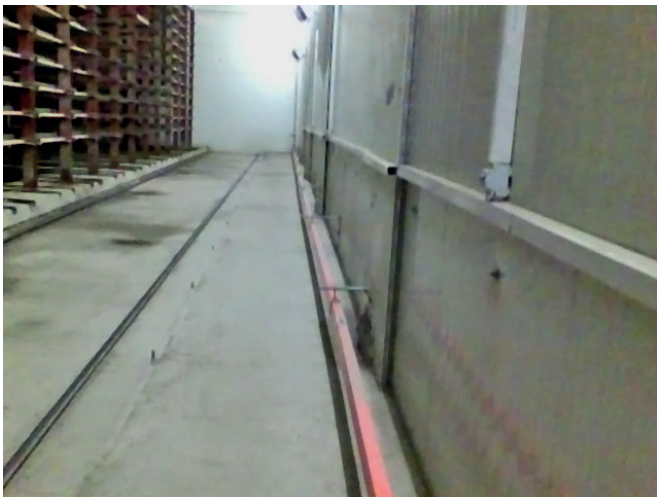
A typical transfer car area with an insulated exterior wall. Damp spots are seen throughout the area and the thermal image shows very well the coldness of the floor in the transfer car area due to poor air circulation. The dark purple spot and areas along the outside wall are indications of cold leaking into the chamber through the concrete floor.

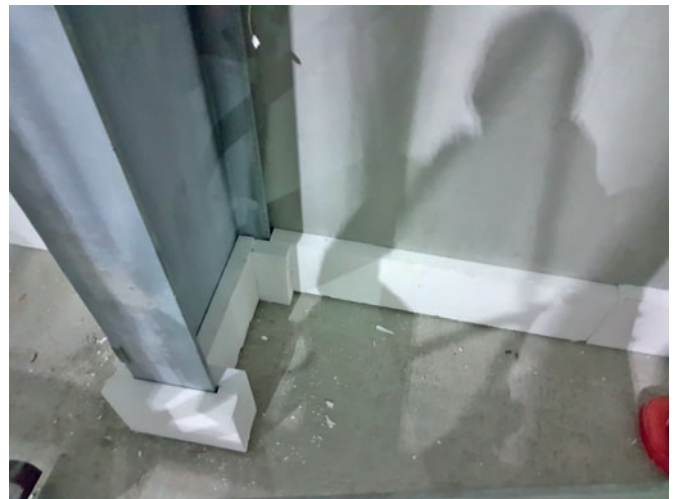
Insulation board is the solution for insulating the perimeter of the curing chamber after installing the rack and rails, but prior to placement of the screeded floor. All steel support beams for the production building must be insulated and isolated from the concrete inside the curing chamber. These steel columns are highly efficient thermal bridges and can cause numerous issues in the way of standing water.

Eliminating the thermal bridge is easiest to do when the curing chamber is in the design and build phase. The use of 40 mm to 80 mm insulation board is inexpensive and installed quickly as a thermal break in the concrete floor or curb around the perimeter of the chamber. This thermal break is as effective as the insulation panel walls at preventing condensation and will, as part of a complete professional solution of air circulation, heating and moisturizing, provide relief from standing water.
