Thermal images help assessing insulation issues in curing chambers

Michael Kraft, Kraft Curing Systems GmbH, Germany

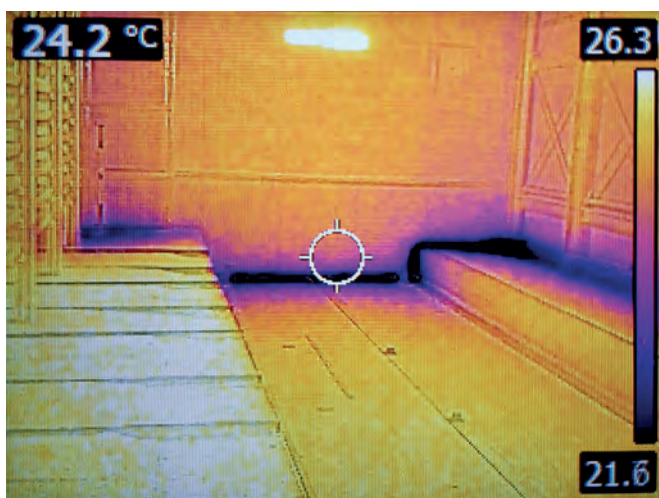
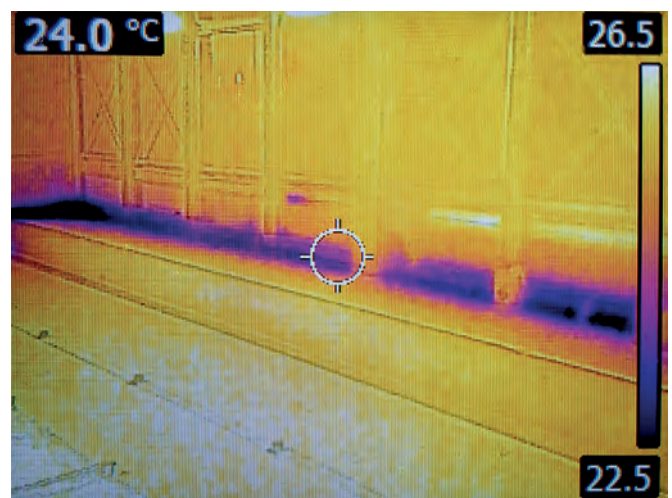
These thermal images show a well heated and circulated curing chamber - only lacking insulation of the concrete slab around the outside of the perimeter of the curing chamber. The floor in the transfer car area is bright yellow to orange, turning to darker purple as it proceeds to the exposed concrete slab. This is especially noteworthy in the recessed transfer car area. Adding insulation to this exposed slab would prevent the chance of standing water in this area.

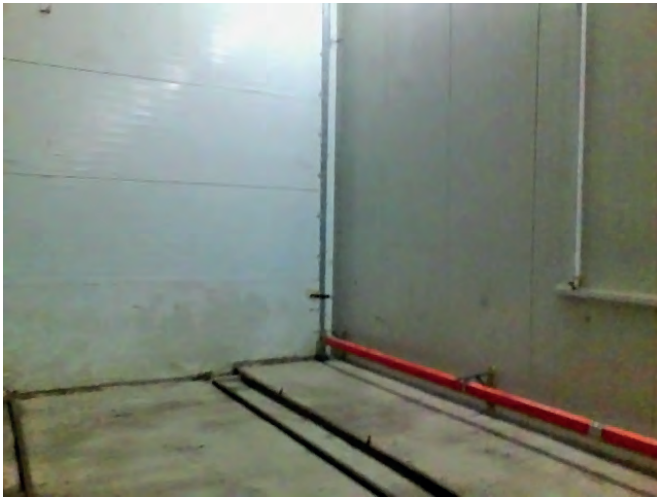
A corner of the curing chamber in which the concrete slab inside the chamber is exposed to the cold weather outside. The standing water may be seen in the picture while the ingress of cold, causing this standing water, is seen as purple on the thermal image.

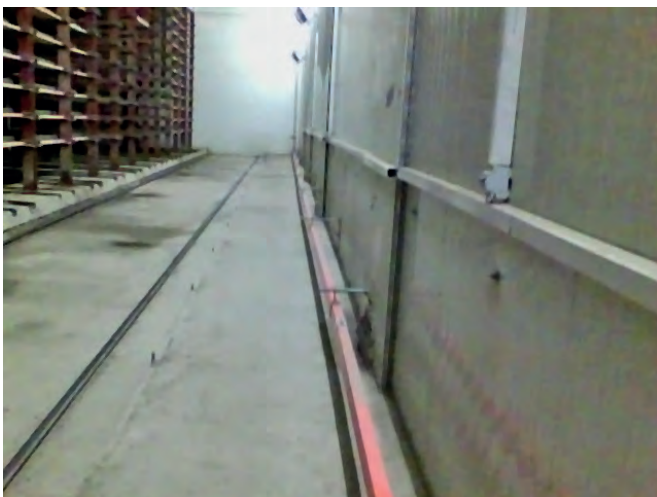
A typical transfer car area with an insulated exterior wall. Damp spots are seen throughout the area and the thermal image shows very well the coldness of the floor in the transfer car area due to poor air circulation. The dark purple spot and areas along the outside wall are indications of cold leaking into the chamber through the concrete floor.

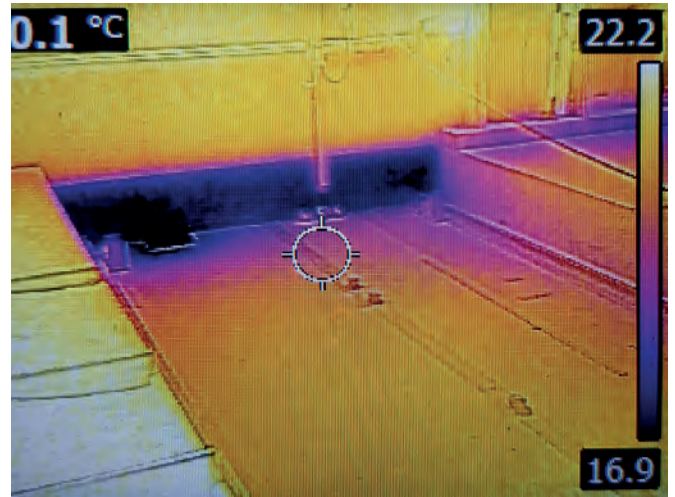
Dark purple areas at the chamber outside perimeter walls lighten slightly as the floor becomes warmer further away from the walls. The high amount of purple throughout the picture indicates poor air circulation.

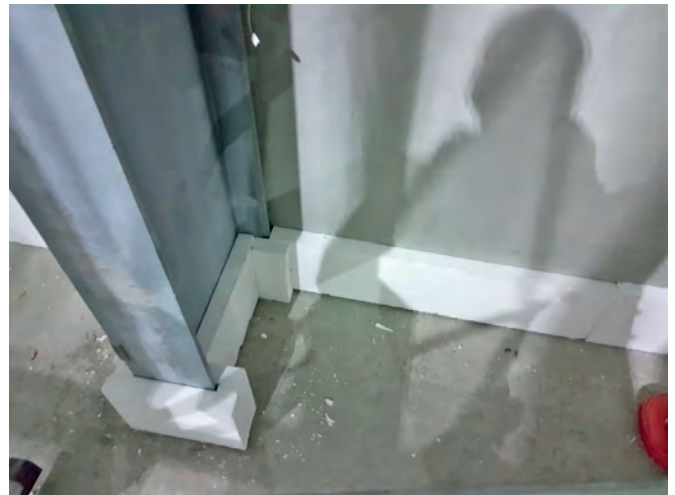
Insulation board is the solution for insulating the perimeter of the curing chamber after installing the rack and rails, but prior to placement of the screeded floor. All steel support beams for the production building must be insulated and isolated from the concrete inside the curing chamber. These steel columns are highly efficient thermal bridges and can cause numerous issues in the way of standing water.

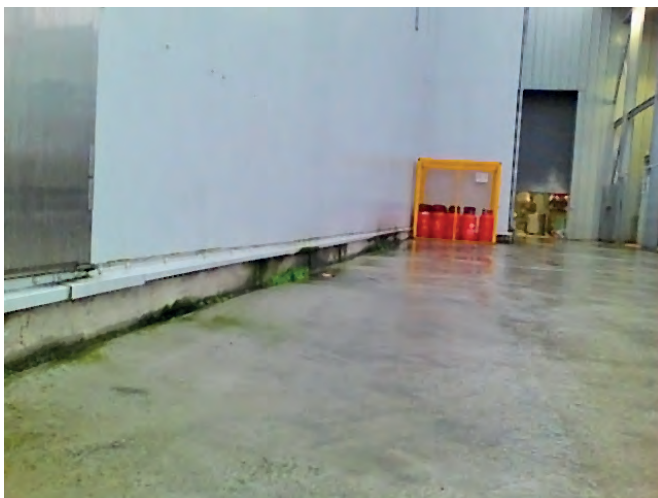
Thermal bridges are also a cause for high energy consumption. These pair of photographs shows very clearly the heat loss from through the raised concrete slab of the curing chamber. With an outside temperature equal to 2°C, this slab is radiating 10°C heat to the atmosphere. Insulating this slab would not only prevent standing water in the curing area, but also reduce energy costs.
