Thermal images help assessing insulation issues in curing chambers

Michael Kraft, Kraft Curing Systems GmbH, Germany

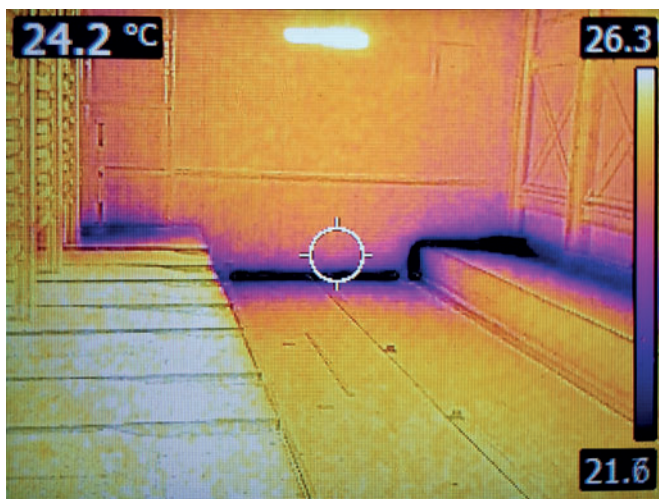
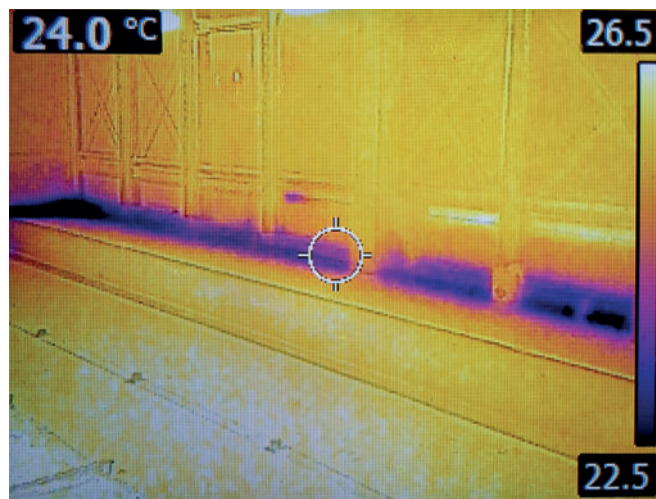
These thermal images show a well heated and circulated curing chamber - only lacking insulation of the concrete slab around the outside of the perimeter of the curing chamber. The floor in the transfer car area is bright yellow to orange, turning to darker purple as it proceeds to the exposed concrete slab. This is especially noteworthy in the recessed transfer car area. Adding insulation to this exposed slab would prevent the chance of standing water in this area.

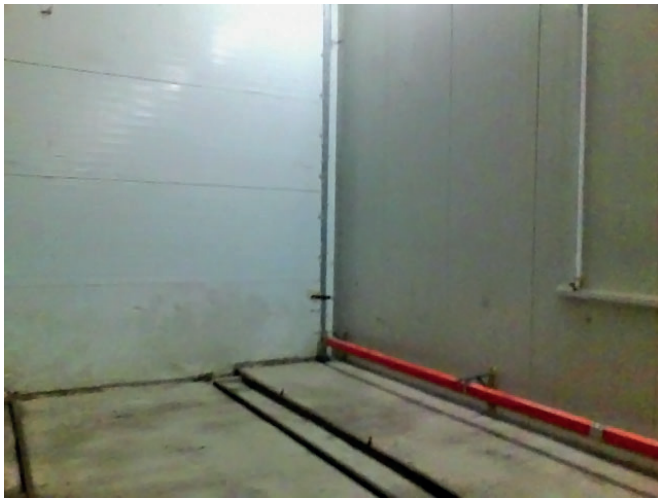
A corner of the curing chamber in which the concrete slab inside the chamber is exposed to the cold weather outside. The standing water may be seen in the picture while the ingress of cold, causing this standing water, is seen as purple on the thermal image.

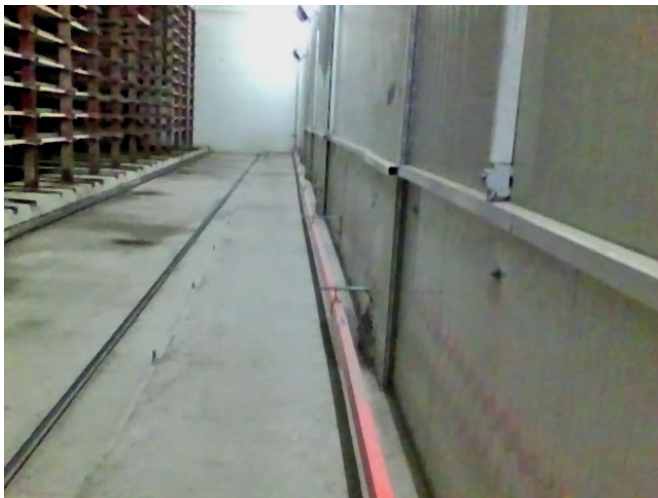
A typical transfer car area with an insulated exterior wall. Damp spots are seen throughout the area and the thermal image shows very well the coldness of the floor in the transfer car area due to poor air circulation. The dark purple spot and areas along the outside wall are indications of cold leaking into the chamber through the concrete floor.

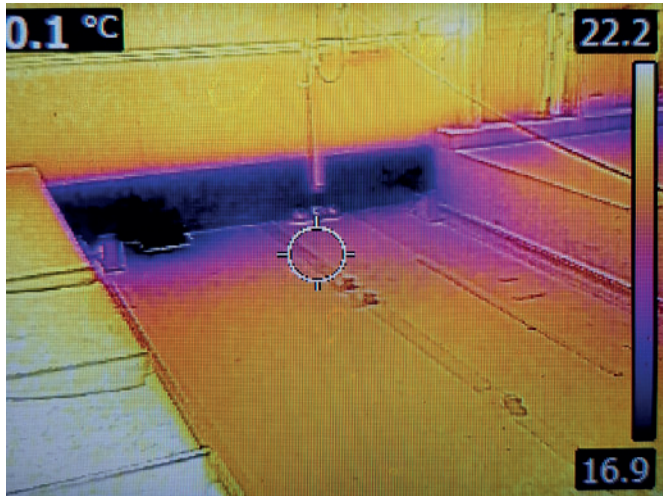
Dark purple areas at the chamber outside perimeter walls lighten slightly as the floor becomes warmer further away from the walls. The high amount of purple throughout the picture indicates poor air circulation.

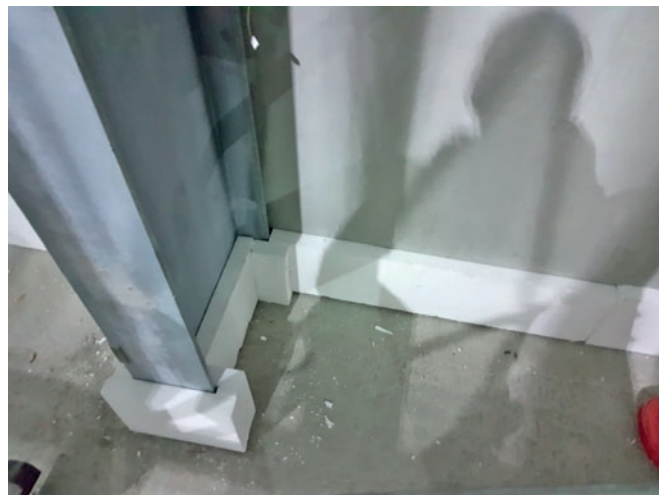
Insulation board is the solution for insulating the perimeter of the curing chamber after installing the rack and rails, but prior to placement of the screeded floor. All steel support beams for the production building must be insulated and isolated from the concrete inside the curing chamber. These steel columns are highly efficient thermal bridges and can cause numerous issues in the way of standing water.

Eliminating the thermal bridge is easiest to do when the curing chamber is in the design and build phase. The use of 40 mm to 80 mm insulation board is inexpensive and installed quickly as a thermal break in the concrete floor or curb around the perimeter of the chamber. This thermal break is as effective as the insulation panel walls at preventing condensation and will, as part of a complete professional solution of air circulation, heating and moisturizing, provide relief from standing water.

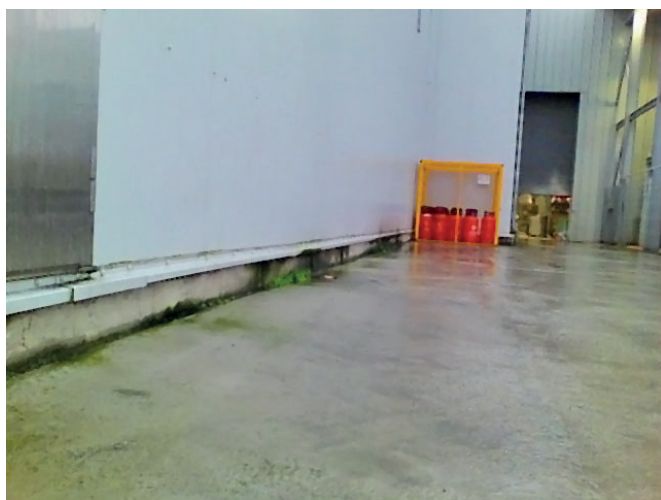
Thermal bridges are also a cause for high energy consumption. These pair of photographs shows very clearly the heat loss from through the raised concrete slab of the curing chamber. With an outside temperature equal to 2°C, this slab is radiating 10°C heat to the atmosphere. Insulating this slab would not only prevent standing water in the curing area, but also reduce energy costs.
