# Current problems in the wear behaviour of concrete block molds

■ Holger Stichel und Stefanie Schaarschmidt,  
Kobra Formen GmbH, Germany ■

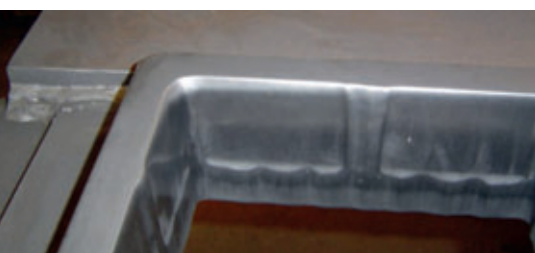
Figure 1: Checking for wear at the lower edge of the mold

The experience of Kobra service engineers shows that wear at the lower edge of the mold has decreased in recent years and occurs only very rarely today. The causes of such wear could be on the one hand mechanical, i.e. in the machine itself, and on the other due to various incorrect settings.

Mechanically related wear can occur, for example, due to damaged rubber buffers on the vibrating table or broken bearings on the mold clamps. Cracks in the vibrating table, the machine frame or defective production boards can also contribute to higher wear, since the mold is subjected to greater stress. Thanks to regular maintenance, however, these defects are only found in exceptional cases in most concrete block plants.

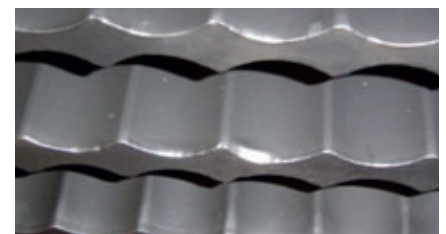
Figure 2: Build-up welding of the lower edge of the mold – before and after

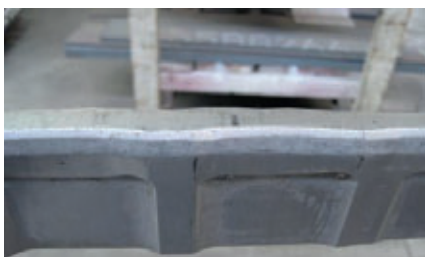
Figure 5: Heavier wear at the upper edge of the mold

If the wear is as advanced as shown in Fig. 5, there is no possibility to perform a build-up weld on the upper edge of the mold since the heat affected zone around the welding seam is too high. The hardness mold necessary for long-term production is lost. A repair, which can be very complex and thus highly expensive, is only of short-term benefit, since heavy wear typically occurs next to the welding seam. In addition, the stresses induced due to the heat input during welding can result in an increased risk of cracking.
